Contract #: 04-0120F4Cty: SF/ALA Rte: 80 PM: 13.2/13.9File #: 13.28**WELDING INSPECTION REPORT****Resident Engineer:** Pursell, Gary**Address:** 333 Burma Road**City:** Oakland, CA 94607**Report No:** WIR-012996**Date Inspected:** 13-Apr-2010**Project Name:** SAS Superstructure**OSM Arrival Time:** 1000**Prime Contractor:** American Bridge/Fluor Enterprises, a JV**OSM Departure Time:** 1830**Contractor:** Oregon Iron Works Clackamas, Or.**Location:** Clackamas, OR

**Hinge-K Pipe Beam Assembly 120A-2:**

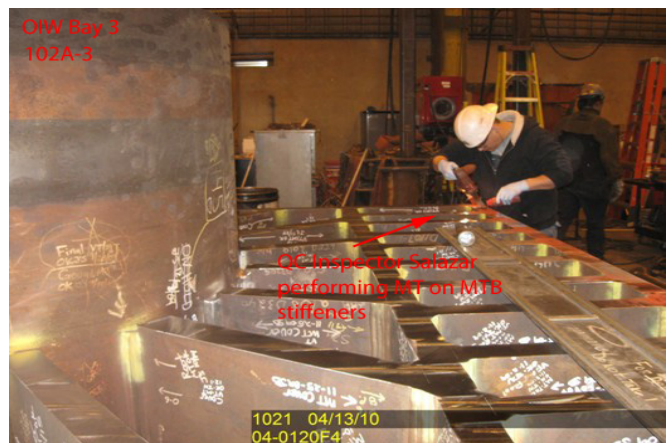
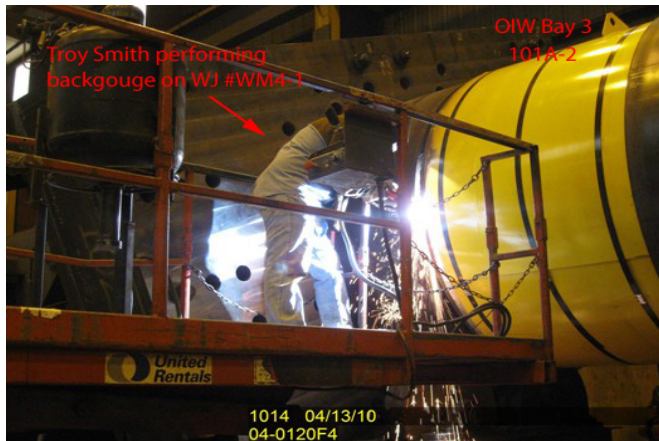
The QA Inspector witnessed OIW QC Inspector Jose' Salazar performing Magnetic Particle Testing (MT) on the completed Mill to Bear (MTB), HPS 485W stiffeners. The QA Inspector noted that the stiffeners had been previously machined to tolerance and the assembly had been placed on the Bay 3 shop floor. QC Inspector Salazar explained that he was performing the testing on the stiffener ends, in accordance to OIW procedure QC -113 Rev. #3 and at this time of testing, no rejectable indications were found. QC Inspector Salazar explained that the testing will continue, during the shift and he will probably resume the testing on the following day. See attached picture below.
